# ***SERVICE NEWS***

VOL. 10, NO. 3, JULY—SEPTEMBER 1983

3 **Controlling Rudder Thrust Rearing Wear**

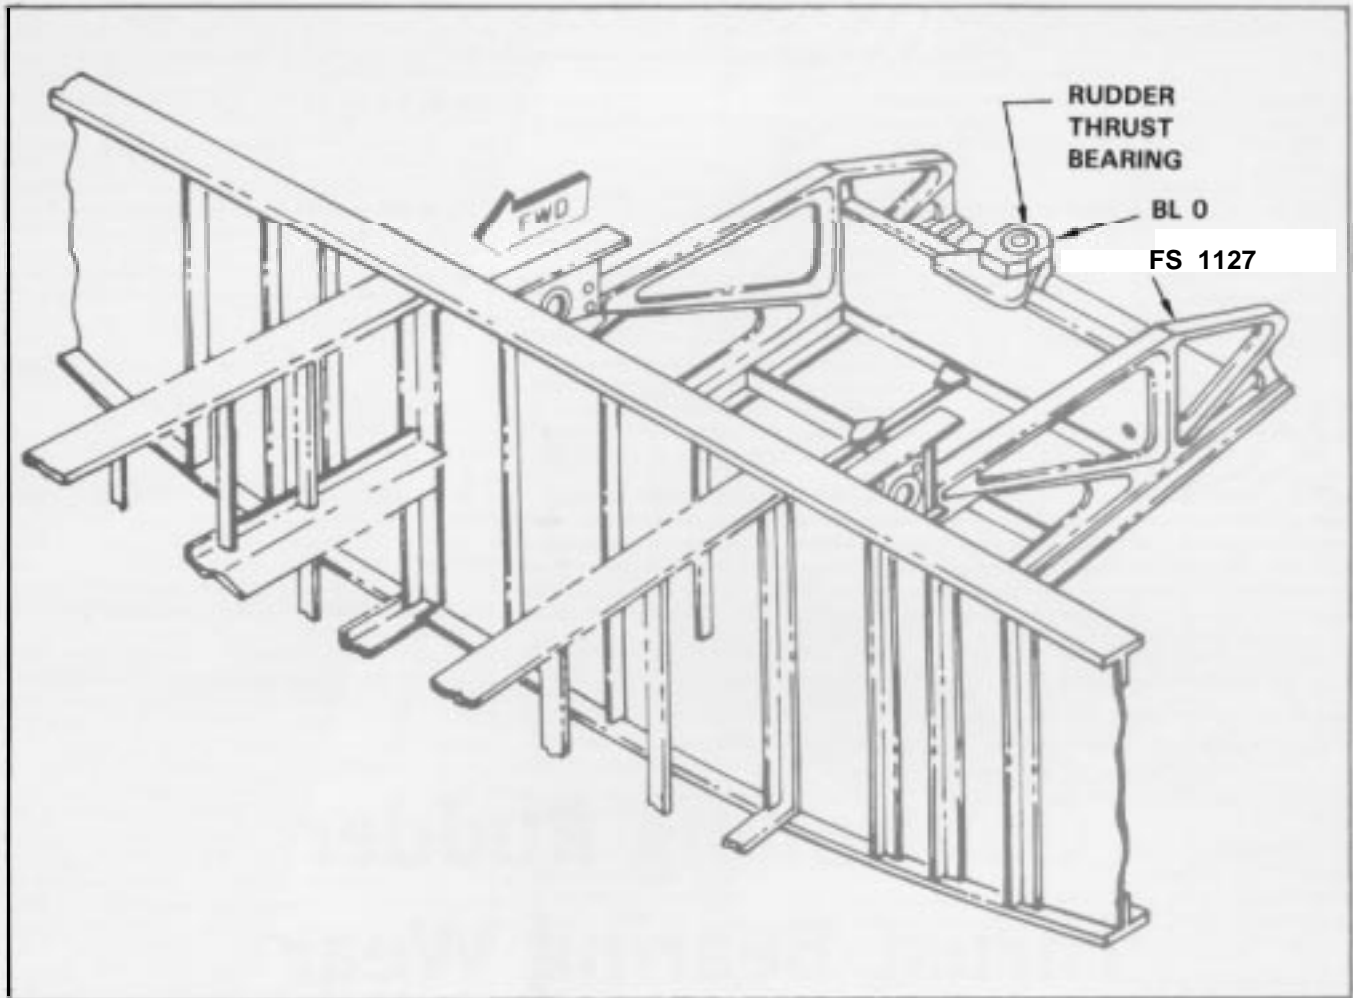
**Figure 1. Rudder thrust bearing location.**

The complaints included such things as jerky, erratic, or sluggish rudder movement, particularly at low airspeeds, and a tendency for the aircraft to “hunt” about the vertical axis (yaw) when the autopilot was engaged. Investigation showed that in most of the aircraft where these conditions were noted, the large roller bearing that supports the weight of the rudder at its base turned out to be seriously worn. Replacement of the affected P/N C-12 or DA12-38AQ rudder thrust bearing (Figure 1) cleared the discrepancies.

yielded strong evidence that the single most important factor in their premature demise was inadequate lubrication. The bearings had been allowed to run dry, and the resultant metal-to-metal contact destroyed the bearing surfaces in short order.

ing properly and none of the symptoms of rudder thrust bearing wear described above are present, the only immediate action recommended is to give the thrust bearing an extra lubrication as a precautionary measure. T.O. IC-130A-6WC-15 specifies that the rudder thrust bearing is to be lubricated with MIL-G-XI322 general-purpose grease, or the equivalent, at each minor and major inspection. In the case of commercial Hercules aircraft, the service bulletins referenced above recommend an immediate extra application of lubricant and then lubrication at intervals of 1800 flight hours or 365 days, whichever occurs first.

Lockheed also recommends that the rudder thrust bearing be routinely replaced whenever the rudder is removed for some reason in the course of a maintenance activity. The cost of the part is minimal compared to the time and effort required to get at it, and installing a new one whenever the rudder is already out of the way will help reduce the chances that the thrust

If the condition of a rudder thrust bearing has deteriorated to the point that it is causing erratic rudder operation, no amount of extra lubrication will restore normal operation. Permanent damage to the bearing has probably already occurred, and the only solution is to replace it.

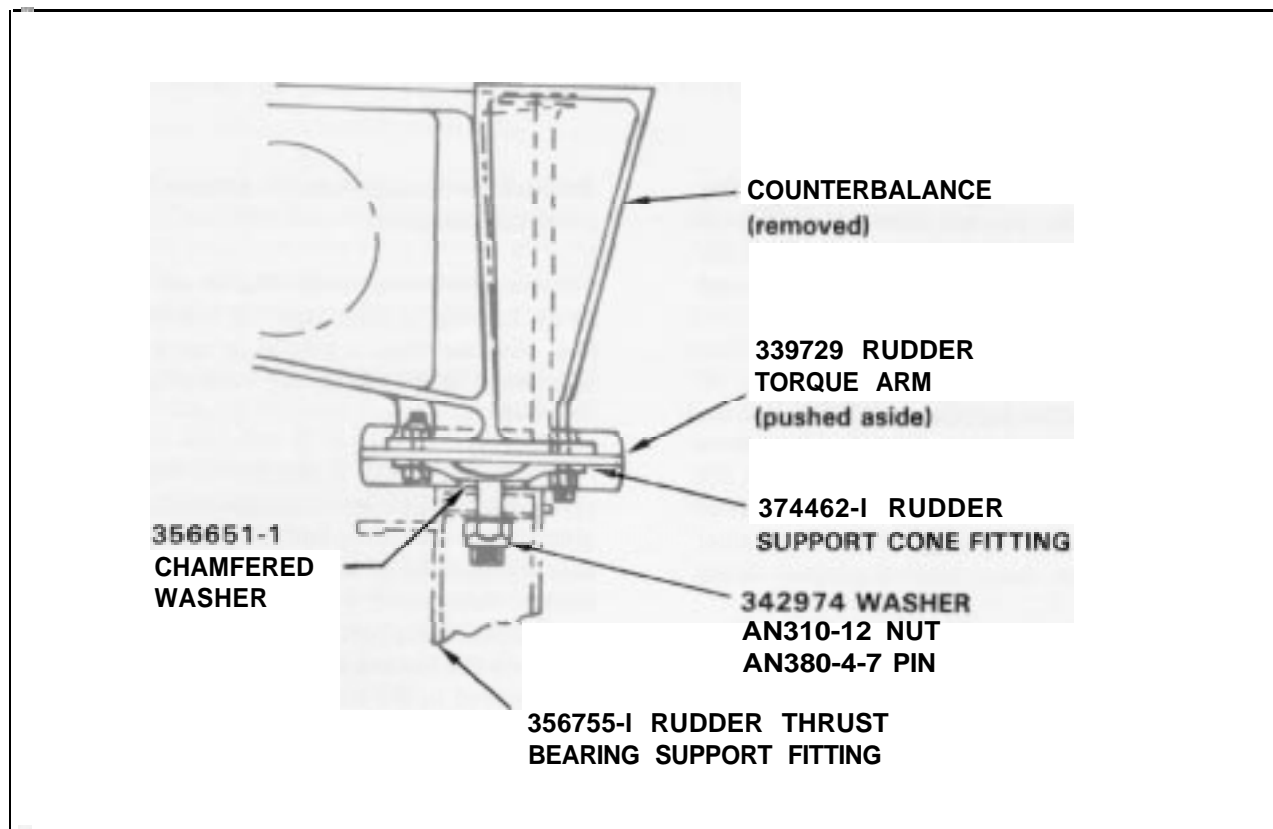
**Figure 2. Counterbalance, torque arm, and rudder support cone fitting with associated hardware.**

pin, the nut, and the P/N 342974 thrust bearing washer from the rudder support cone fitting (Fig. 2). Examine the nut and washer for signs of damage, corrosion, or wear. If they are sound, they may be saved for reinstallation.

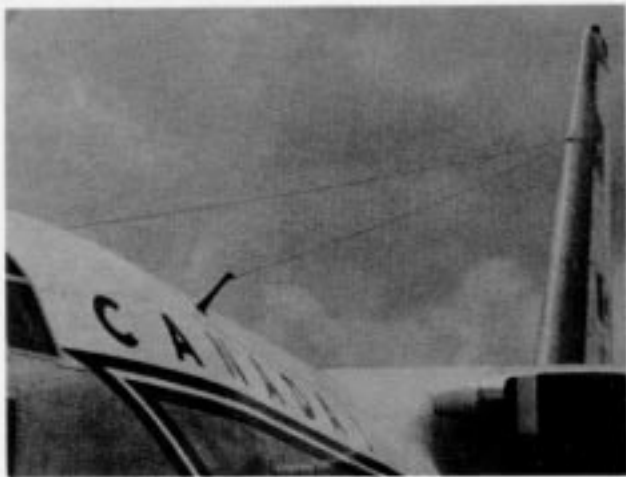
**Figure 1.** The forward end of each HF antenna wire is anchored to an AML-61 antenna mast.

The most common cause of wire failure has been shown to be corrosion. Laboratory examination of the chuck assemblies in a number of cases where the antenna wire had failed indicated that the principal corrosion product was iron oxide (rust) from the copper-coated steel antenna wire and copper-coated steel chuck spring. The stainless steel chuck assembly body and spring locating screw and the brass chuck jaws are apparently not corroding. An exploded view of the wire chuck assembly and its installation is shown in Figure 2.

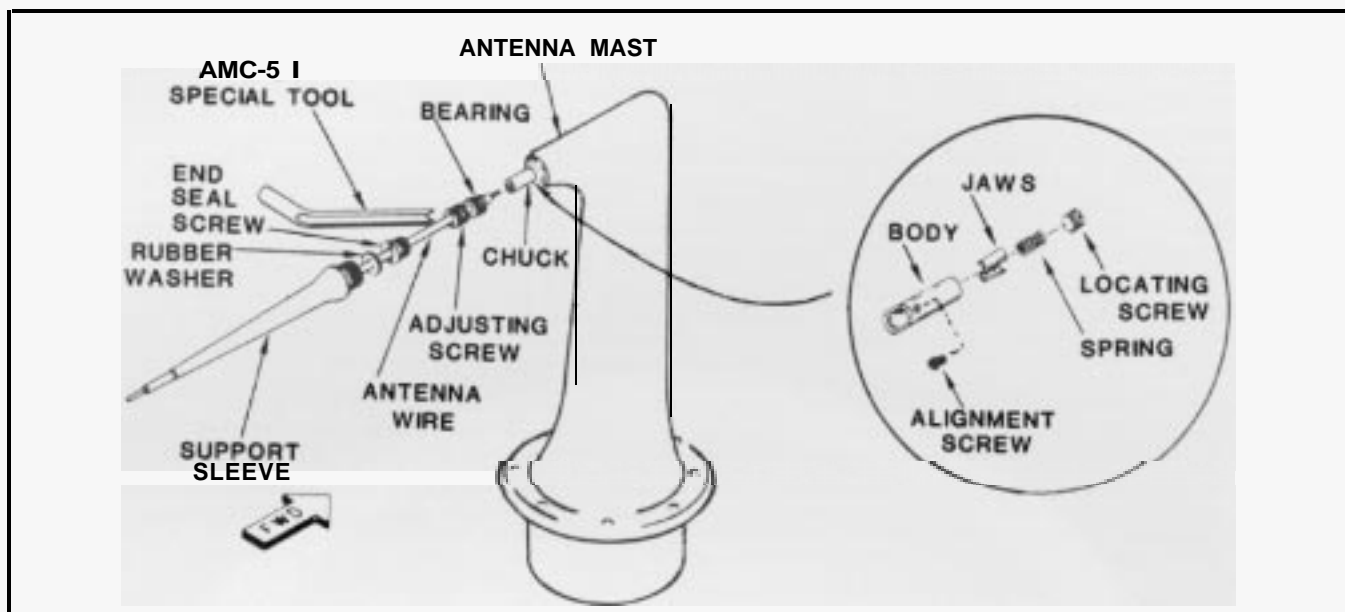
**Figure 2 AMV-61 antenna mast assembly and chuck assembly detail**

Evidently, the problem begins when the copper coating of the antenna wire is broken during preparation for installation. If the wire is nicked at all, it exposes the steel core of the wire, which subsequently rusts. The copper coating on the spring is probably rubbed off during normal service use, which causes the exposed steel to rust when moisture enters the antenna mast.

Lockheed engineering recommends three steps to be taken to prevent corrosion within the antenna mast: proper assembly of the antenna mast and wire, proper preparation of the antenna wire, and the addition of a corrosion preventive compound to the chuck assembly.

Slide all of the antenna mast attaching parts (except the chuck) onto the antenna wire, as illustrated in Figure 2. They go on in this order: antenna support sleeve, rubber washer, end seal screw, and the adjusting screw. These parts should be pushed back on the wire approximately 12 inches before attaching the antenna. Slip the antenna wire bearing over the conductor and insert the full length of the bare wire conductor into the chuck assembly. Three or four sharp in-and-out motions should be made to ensure proper gripping of the conductor by the chuck jaws.

After assembly, carefully remove the locating screw on the end of the chuck assembly and fill it with corrosion preventive compound. Also, sparingly apply corrosion preventive compound to the outside junction point between the chuck jaws and antenna wire. Remove any compound that may get on the exterior of the chuck assembly so that the wire will bond electrically in the fitting when installation in the mast is complete.

Reinstall the chuck assembly locating screw. The suggested corrosion preventive compounds are listed below in order of preference: MIL-S-8660, silicone compound (Dow Corning DC-4); MIL-G-6032, plug valve grease; MIL-C-11796, Class 1, corrosion preventive compound; or MIL-C-16173, Grade 1 or 4, corrosion preventive compound.
