**AIRCRAFT SERIOUS INCIDENT
INVESTIGATION REPORT**

**JETSTAR AIRWAYS PTY LTD.
V H V K J**

CASE EQUIVALENT TO CONTINUED LOSS OF THRUST OF ENGINES IN FLIGHT JETSTAR AIRWAYS PTY LTD.

BOEING 787-8, VHVKJ

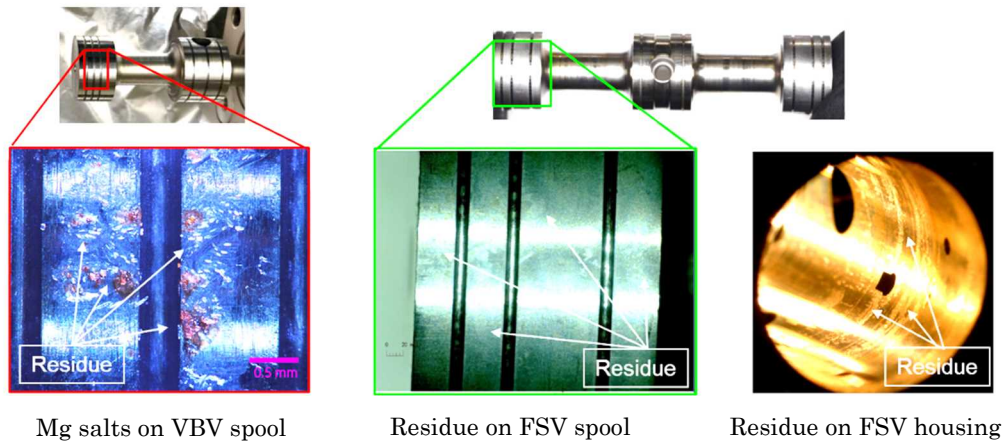
Figure 8: Residue primarily composed of Mg salts

- ii) FSV spool and VBV spool of both engines did not move with Residue primarily composed of Magnesium salts being detected. Composition of the detected Residue primarily composed of Magnesium salts were similar to the ones of biocide (Kathon FP1.5). FSV spool, if it is under normal condition, moves on a test stand by the force of 0.5 lbs*⁵; however, the spool did not move even by applying the force of 160 lbs. Magnesium salts and residue were detected from FMV spool, HPT ACC spool and VSV spool of the left engine.

(3) It is highly probable that Residue primarily composed of magnesium salts accumulated in FMV spool and FSV spool, which meter engine combustion fuel, restricted movement of spools, caused inadequate fuel metering, thereby led to engine rpm oscillation that occurred from the first flight after conducting biocide treatment.

(8) From the biocide test result, it is probable that Magnesium salts contained in biocide did not dissolve in fuel, but dissolved in water contained in fuel and were accumulated in spools as crystals through the engine fuel system.

(1) The Operator suspended biocide treatment using Kathon FP1.5 inside fuel tanks of the same type of aircraft. The Operator is reviewing maintenance procedures that occur infrequently, to identify task- specific training opportunities for maintenance personnel based on AMM.

(2) The design and manufacturer of the engine issued service bulletin (SB) for aircraft equipped with GEnx engine to notify operators to suspend biocide treatment using Kathon FP1.5. (SB 73-0086 R00 ENGINE FUEL AND CONTROL – GENERAL (73-00-00) – SUSPENSION OF THE USE OF KATHON FP 1.5 BIOCIDES TREATMENT ISSUED SEP/30/2019)

(3) The design and manufacturer of the aircraft deleted biocide treatment procedures using Kathon FP1.5 from the AMM of the same type of aircraft equipped with GEnx engine following SB issued by the design and manufacturer of the engine. The design and manufacturer of the aircraft also updated the AMM for all models of aircraft to explicitly describe the maximum allowable biocide concentration ratio and to record calculation of biocide amount and the amount used.

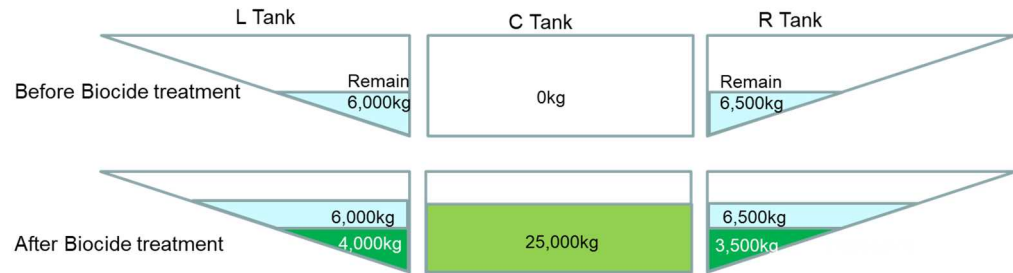
Figure 11: Image of loaded amount pre- and post-biocide treatment

According to the CS (Certifying Staff), they dosed biocide (Kathon FP1.5) as prescribed in AMM during biocide treatment of fuel tank of the Aircraft on March 27. The CS loaded fuel up to 25,000 kgs in concentration ratio of about 100 ppm into the center tank because remaining fuel in the center tank of the Aircraft before biocide treatment was 0 kg. Because 6,000 kgs of fuel remained in the left tank and 6,500 kgs in the right tank, respectively, the CS calculated and loaded additional fuel to make final concentration ratio of about 100 ppm by volume to 10,000kgs as shown in Figure 11. There were maintenance records related to the biocide treatment work, however, calculation of biocide

concentration ratio for each tank and the dosage amount were not kept recorded.

(5) From the results of the interview with the CS who was in charge of biocide treatment work, it is probably that the CS calculated according to the AMM so that the recommended final concentration ratio in the tanks would be about 100 ppm, and additionally loaded the treated fuel as described in 2.7 (11). According to the AMM calculation formula, the concentration ratio of the additional biocide treated fuel is calculated to be about 250 ppm in the left tank and about 285 ppm in the right tank. However, there was no record of the calculation of the concentration ratio of the biocide and the dosage amount. It is desirable to keep these records because they are considered to be important for traceability of maintenance work.

(6) From the result of investigation on the inside of fuel tanks after the serious incident, it is somewhat likely that the fuel with higher concentration ration of biocide, which was supplied to the engines did not mix evenly inside the fuel tanks because no residue of microbial or biocide was found inside the fuel tanks and in the sampled fuel.
