# ***SERVICE NEWS***

VOL. 10, NO. 3, JULY—SEPTEMBER 1983

3 **Controlling Rudder Thrust Rearing Wear**

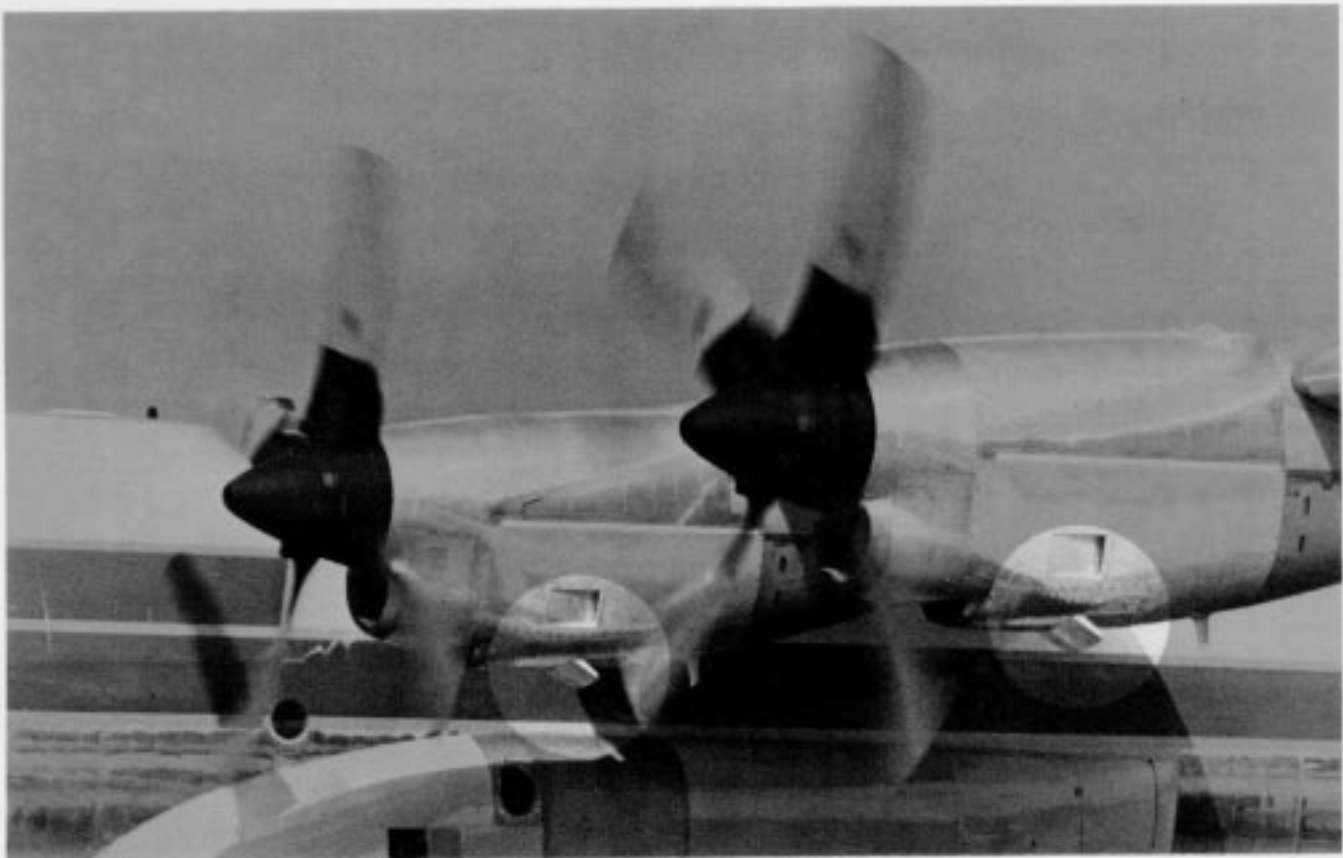
Figure 2. Oil cooler flaps-shown full open prior to takeoff.

One such occurrence involved a Hercules aircraft equipped with three glass-mercury thermostats and one solid-state thermostat. On the ground, with all oil cooler flap switches in automatic, the cooler flaps were full open (Figure 2). As power was applied for takeoff, the oil cooler flaps that were controlled by the glass-mercury thermostats moved toward the closed position and the oil temperatures stabilized at 85°C. The cooler flap controlled by the solid-state thermostat remained open until the oil cooler flap switch was placed to CLOSE. When the flap reached 40%, the switch was placed back to AUTOMATIC, at which time the flap continued to close to about 5% open. With this oil cooler flap at 5%, the oil temperature stabilized at 76°C.

controlled oil cooler flap did not automatically close in this case can be traced to the interaction of the oil temperature control thermostat and the thermostatic bypass and relief valve assembly in the oil cooler regulator valve.
